MALIBU CREEK WATERSHED  
Ecosystem ON THE **Brink**

A SCIENTIFIC ROADMAP FOR PROTECTING A CRITICAL NATURAL RESOURCE

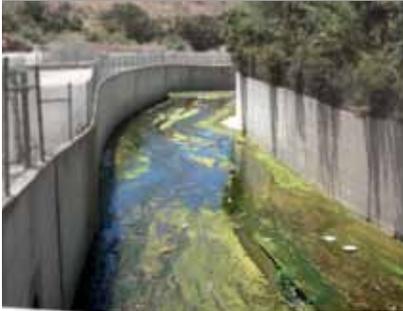
How the Malibu Creek Watershed Is Broken	
<p>Channelization of streams and streambank armoring are common throughout the watershed, causing erosion and negative impacts to stream ecology.</p>

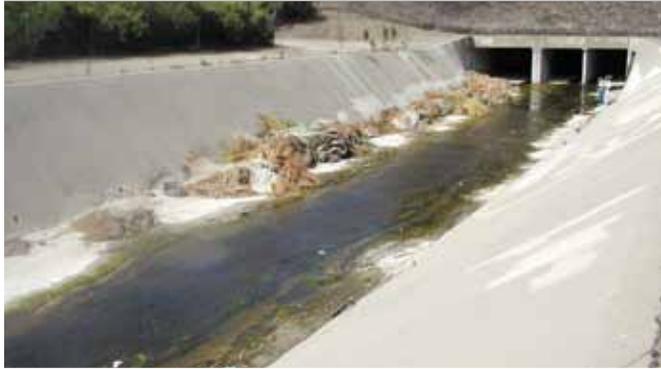
Medea Creek Outlet is a highly degraded site

The SHI scores range from 5 at the Medea Creek outlet, which is a highly degraded site, to 27 at Upper Cold Creek, one of the least impacted reference sites. In general, reference sites receive the highest SHI scores, with sites in the middle and lower watershed receiving much lower scores. The mean SHI score for outlet sites is 9.8, sites in the middle of the watershed have an average SHI score of 10.9, and the mean SHI score for reference sites is 22.7. The decreasing scores from the upper watershed to lower watershed may indicate that considerable degradation is occurring in the mid-watershed, directly below areas impacted by development and high human use.

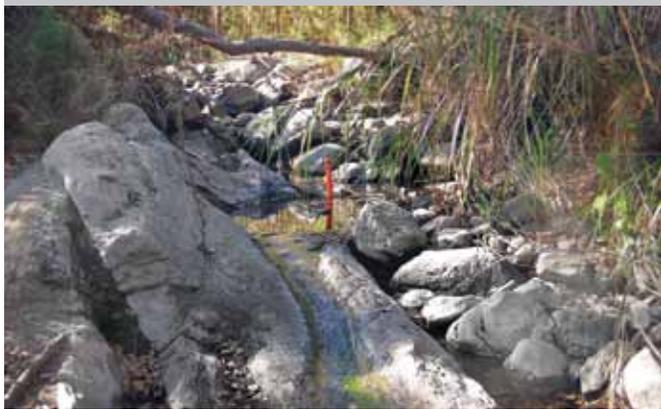
Upper Cold Creek is one of the least impacted sites

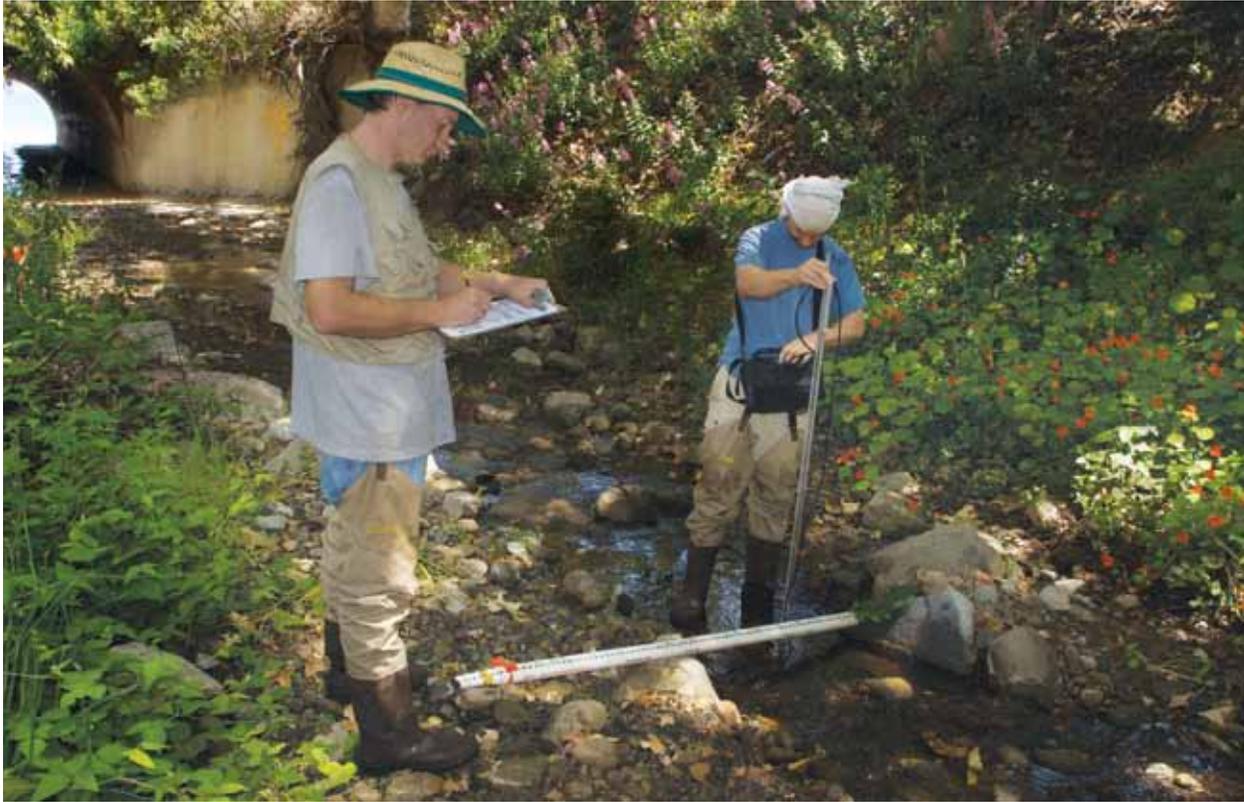
*Stream Team members conducting habitat bioassessment. Photo credit: Heal the Bay*

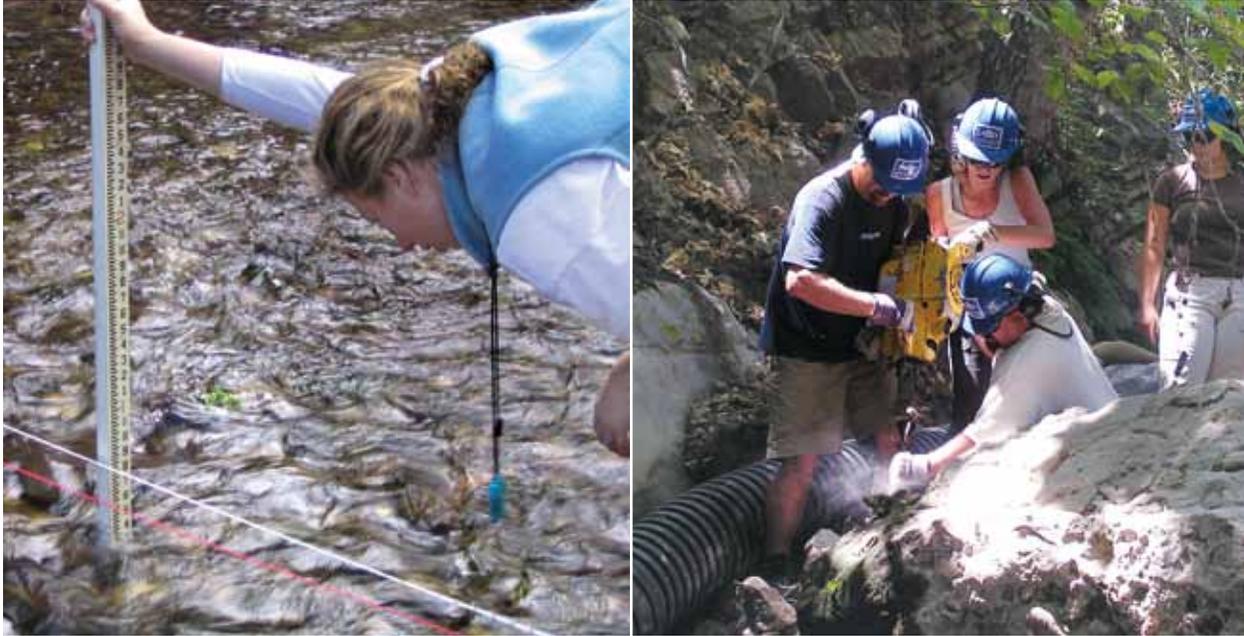
Left: Stream Team member measuring water depth. Right: Barrier removal by jackhammer at Solstice Canyon. Photo credit: Heal the Bay

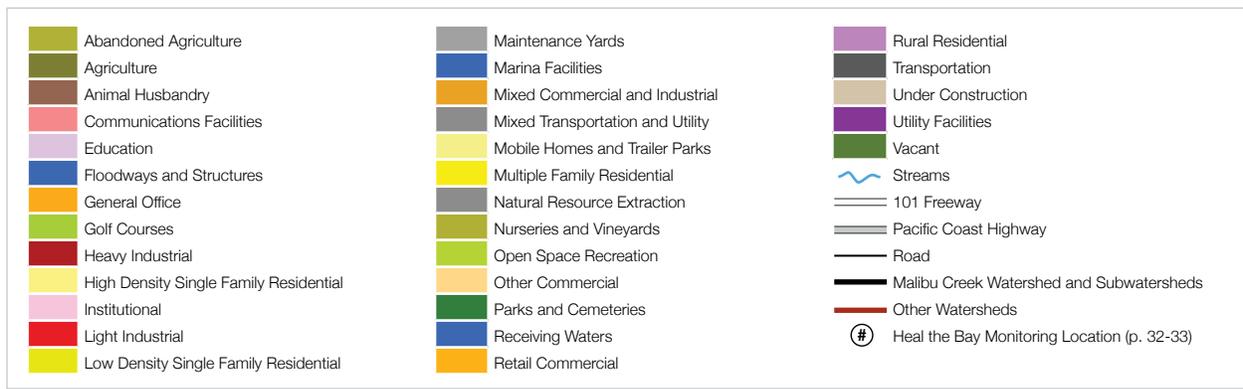
Figure 2-1: Malibu Creek Watershed SCAG Land Use Map (2001)

FIGURE 2-1: Land uses in the Malibu Creek Watershed and adjacent watersheds based on SCAG data and aerial photos.

toring site locations in the watershed and identify prospective areas to examine for potential upstream sources of pollution. Figure 2-1 shows the 2001 SCAG land use data for the Malibu Creek Watershed. With the potential for new development at several sites in the watershed, understanding the impacts of land use change is of utmost importance for guiding future development and watershed management.

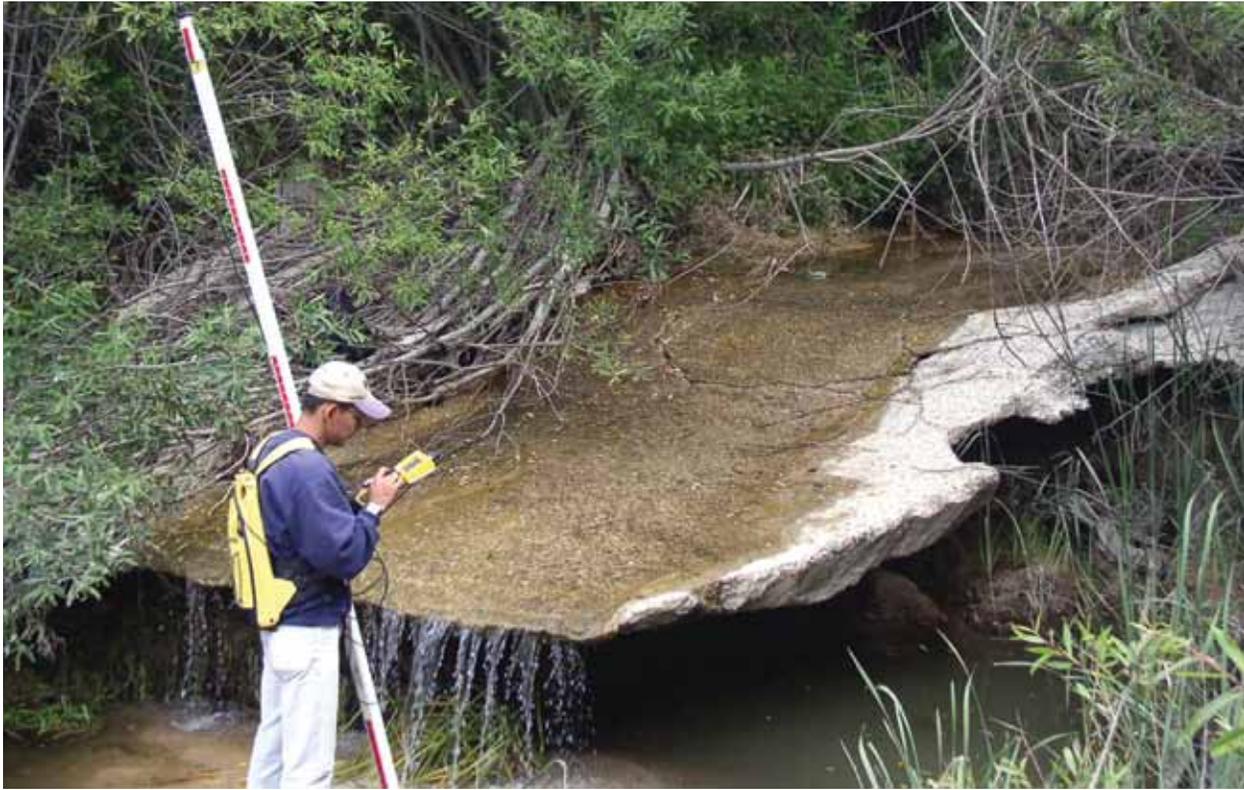
*Stream Team staff mapping hardened streambank modification. Photo credit: Heal the Bay.*

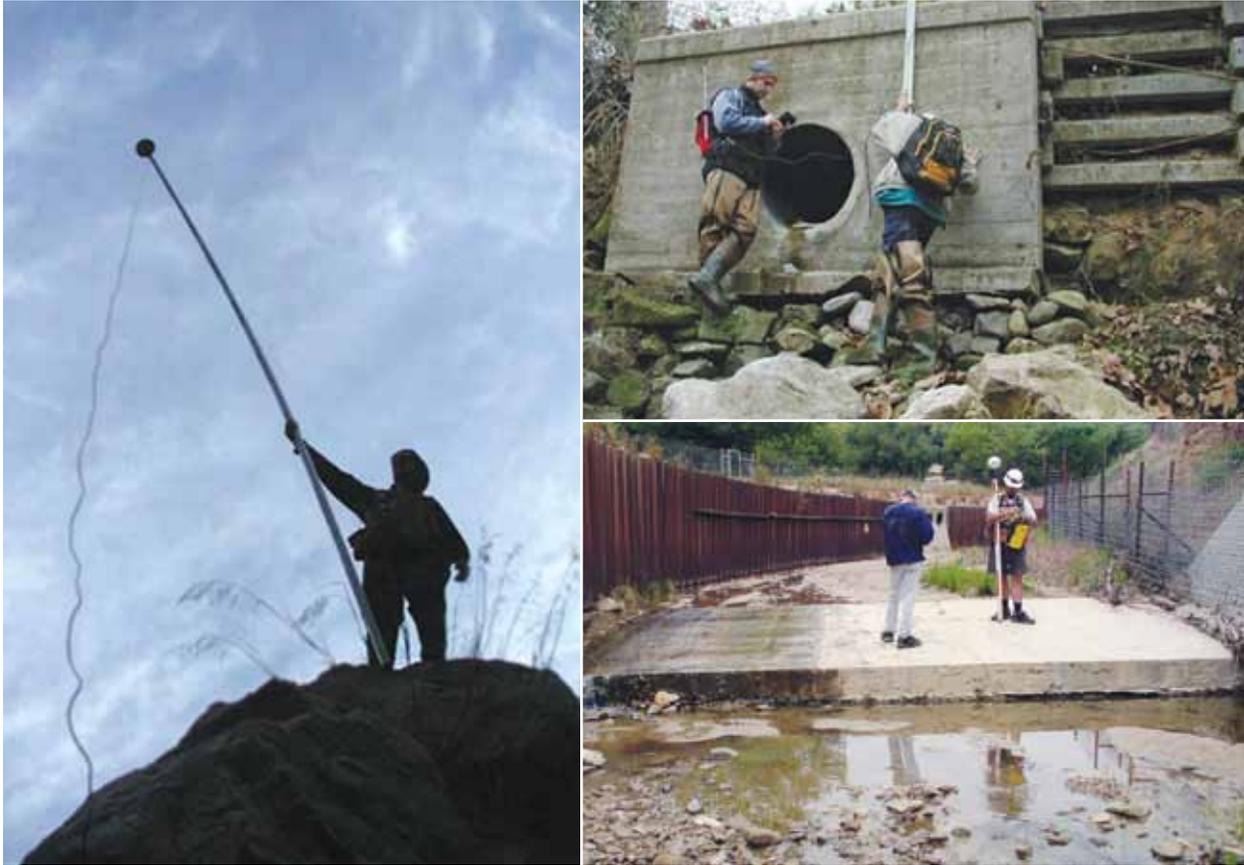
Mapping impairments in the watershed through the Stream Walk program (left), such as discharge points (right top) and streambank hardening (right bottom).

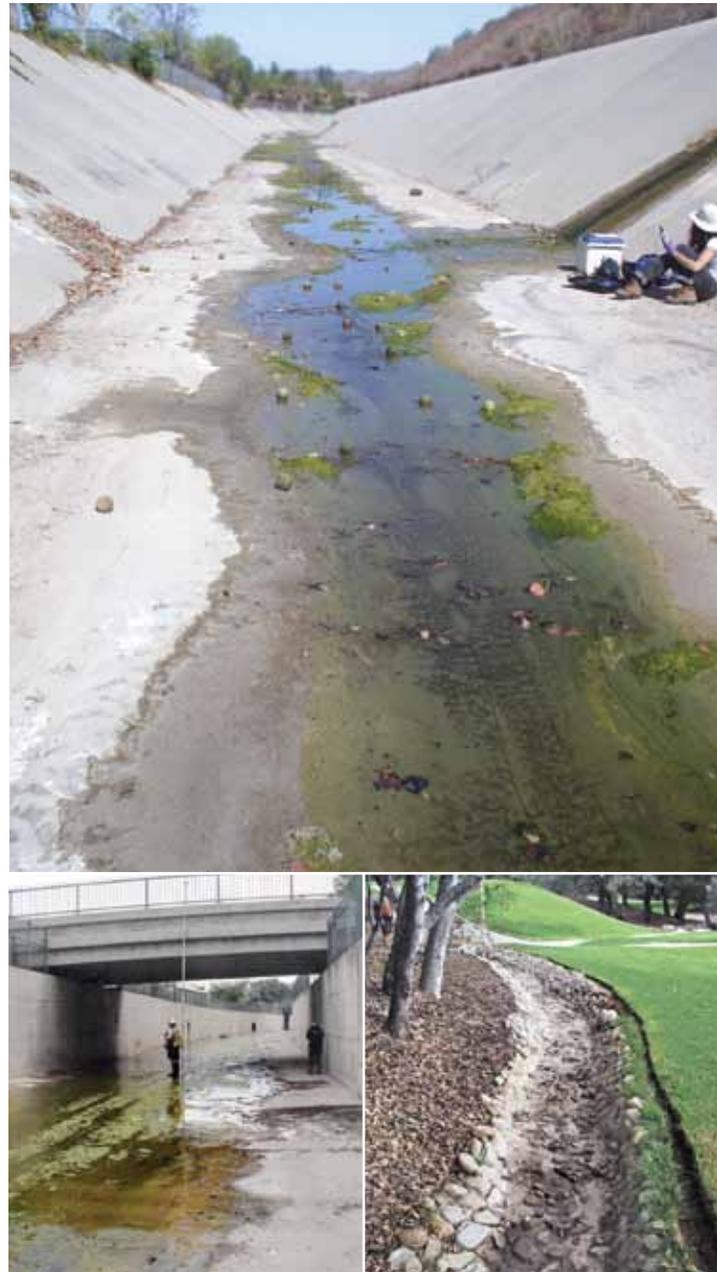
Clockwise from top: Channelized upper Las Virgenes Creek; Channelized Lindero Creek; Channelized Medea Creek. Bottom: Photo credit: Heal the Bay

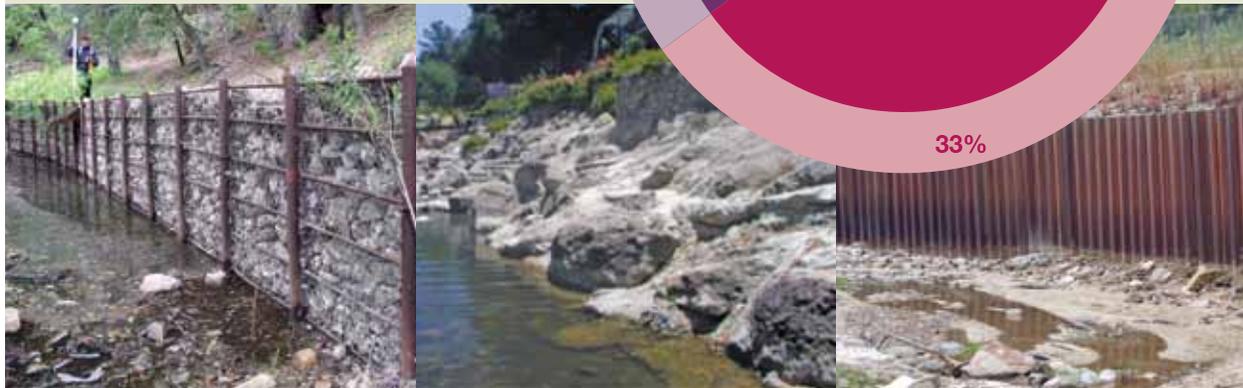
Photos (left to right): Fencing and gabion, concrete boulders, corrugated fencing.

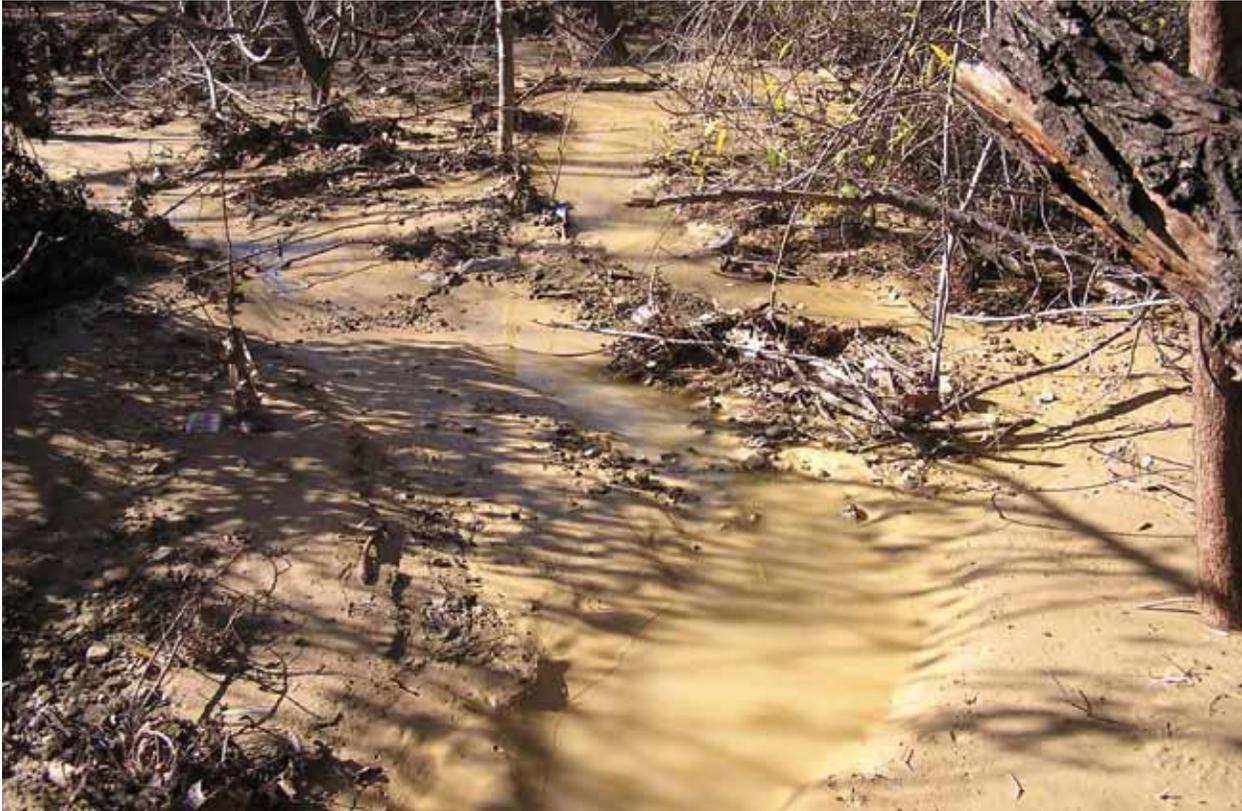
Abnormally high sediment in Las Virgenes Creek due to construction site (see page 99). Photo credit: Heal the Bay

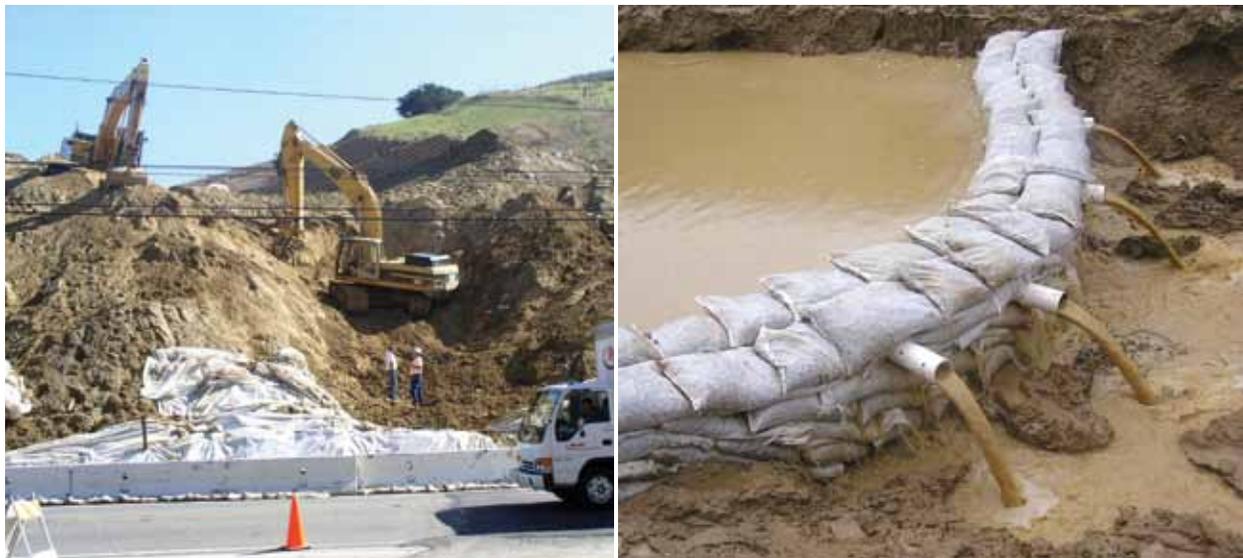
In March 2004, Heal the Bay's Stream Team documented severe construction related runoff from the Shea Homes development located along the east slope of Las Virgenes Road in Calabasas. See page 99 for details. Photo credit: Heal the Bay

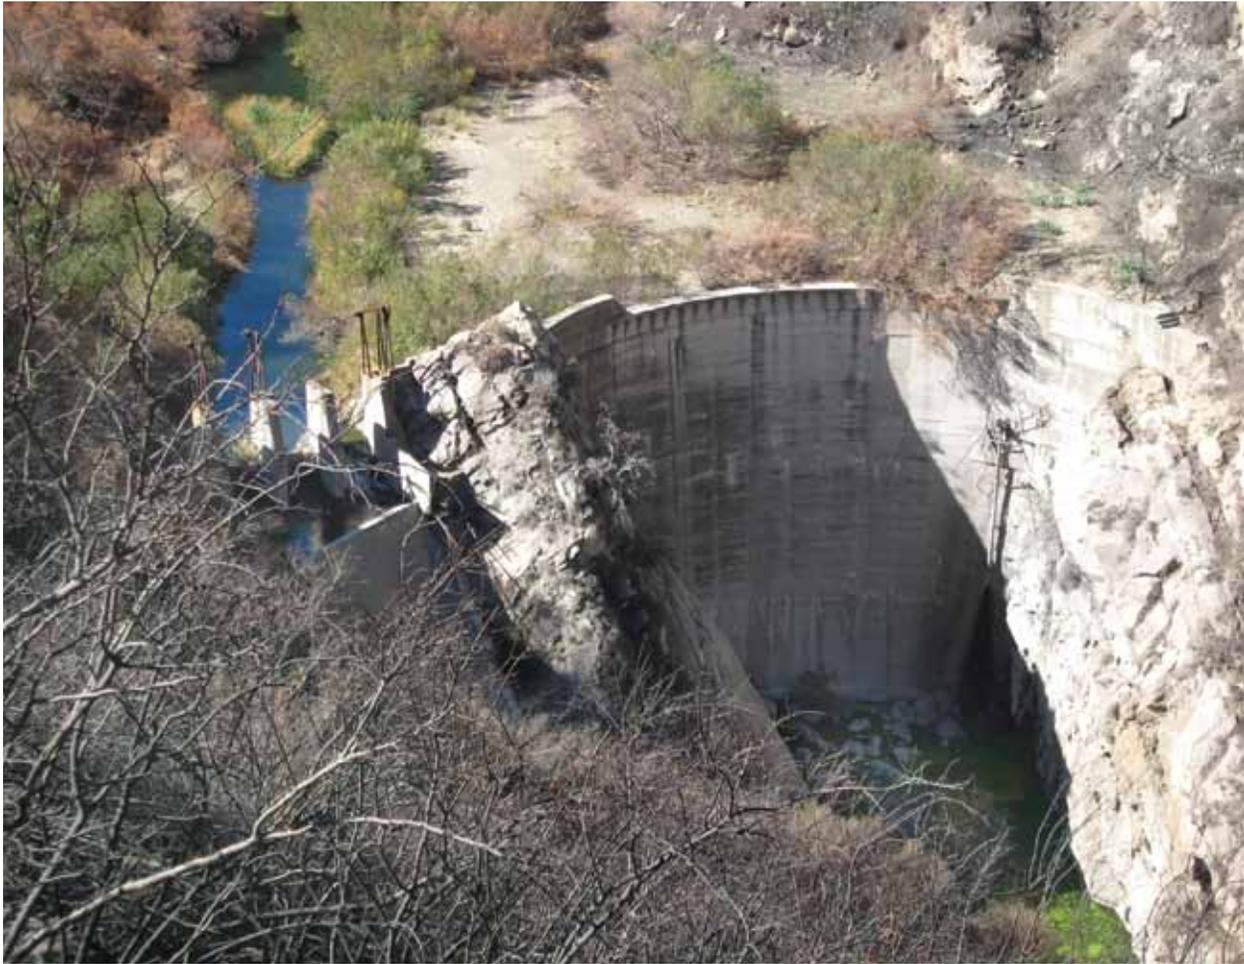
Rindge Dam. Photo credit: Heal the Bay

Rindge Dam, built in 1926, is a 100-foot dam located in the lower watershed of Malibu Creek about three miles upstream from the Malibu Lagoon. The dam was originally created as a reservoir, but quickly filled with sediment and no longer effectively serves this purpose. Beginning in 1999, the Army Corps of Engineers began a feasibility study to assess removal options for Rindge Dam. Fourteen years later, the study has yet to be completed, despite the already significant amount of financial and public resources devoted to the project. Completing the feasibility study is necessary to fully examine the potential options for dam removal and the benefits of the project, such as improving the quality of and access to fish and amphibian habitat in the Malibu Creek Watershed. The Army Corps of Engineers has recently reconvened the Rindge Dam Technical Advisory Committee and has re-engaged efforts to plan for Rindge Dam removal.

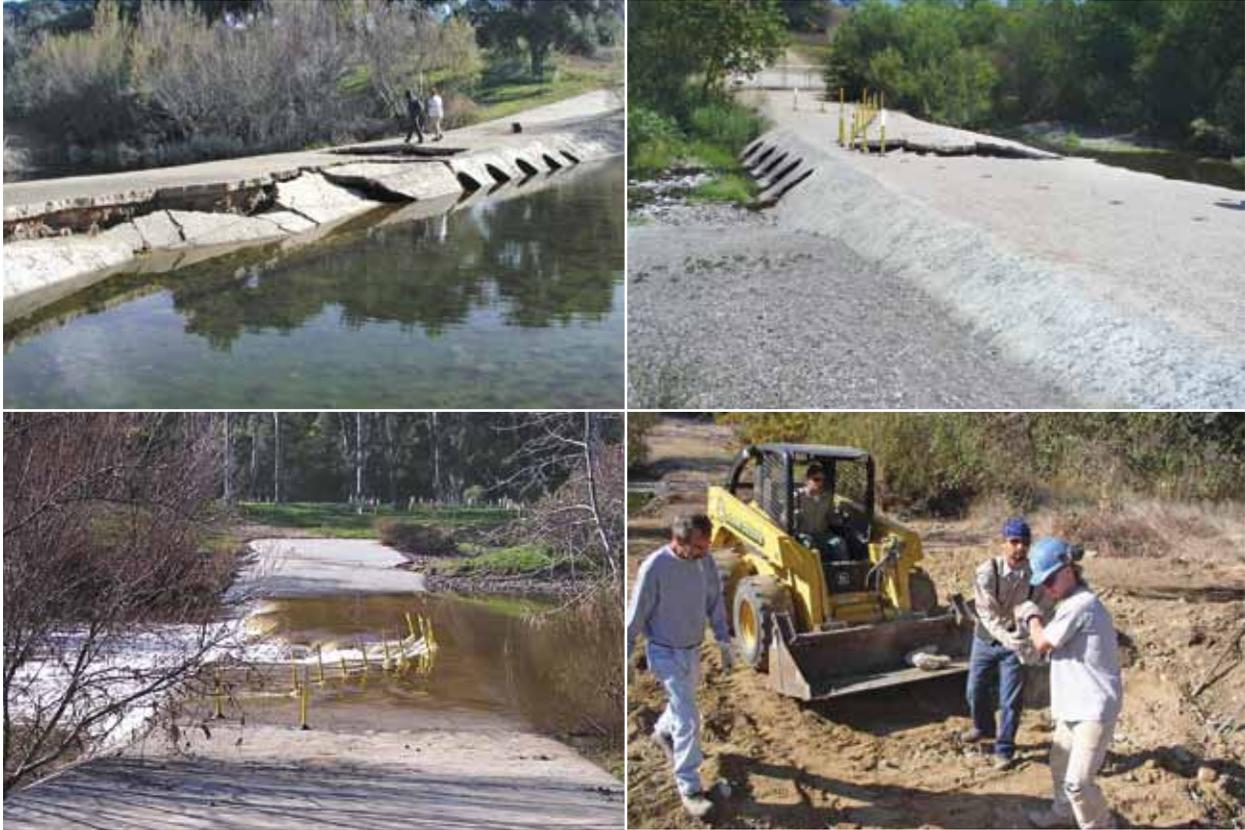
Top row and bottom left: Texas Crossing barrier in Malibu Creek. Bottom right: Heal the Bay team and State Parks staff remove Texas Crossing barrier in October and November 2006. Photo credit: Heal the Bay

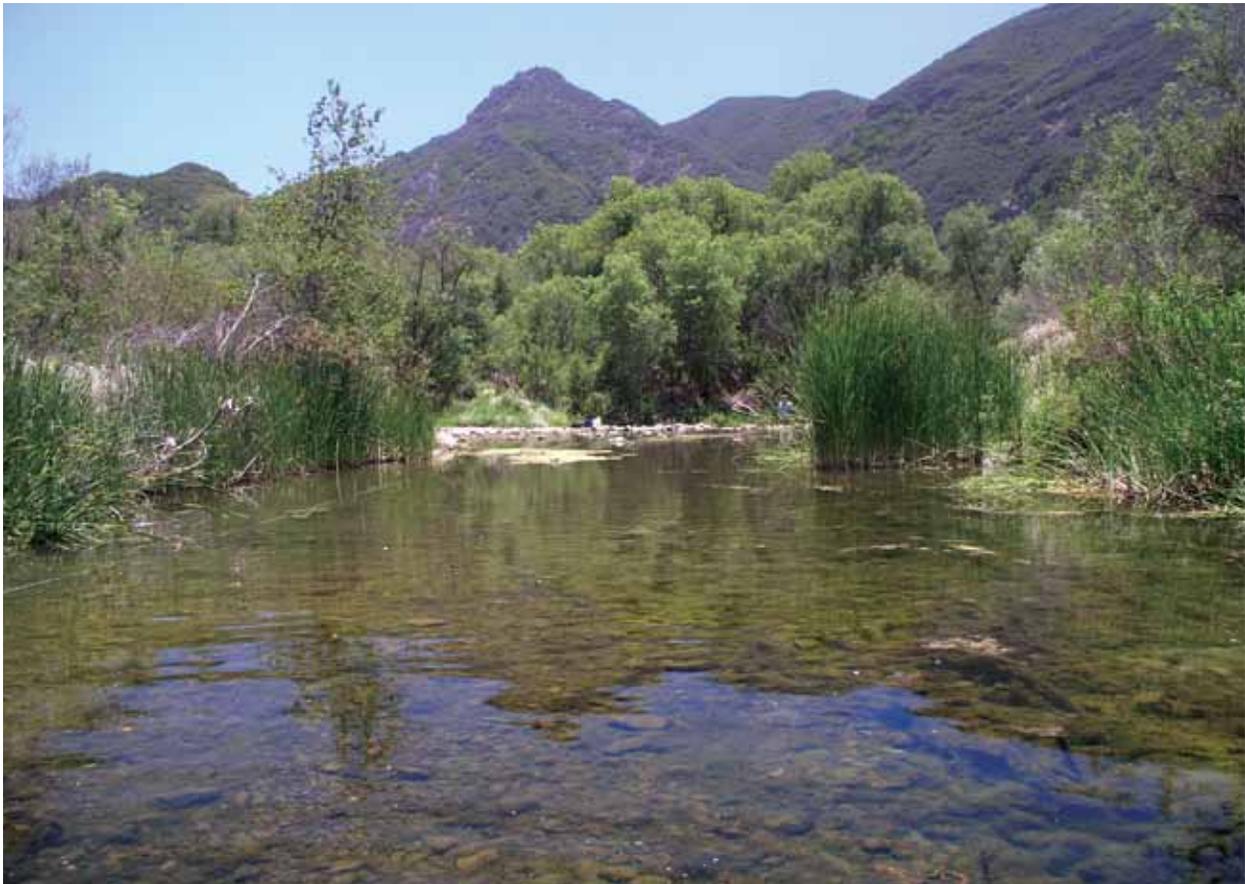
Malibu Creek today after removal of the Texas Crossing barrier. Photo credit: Heal the Bay

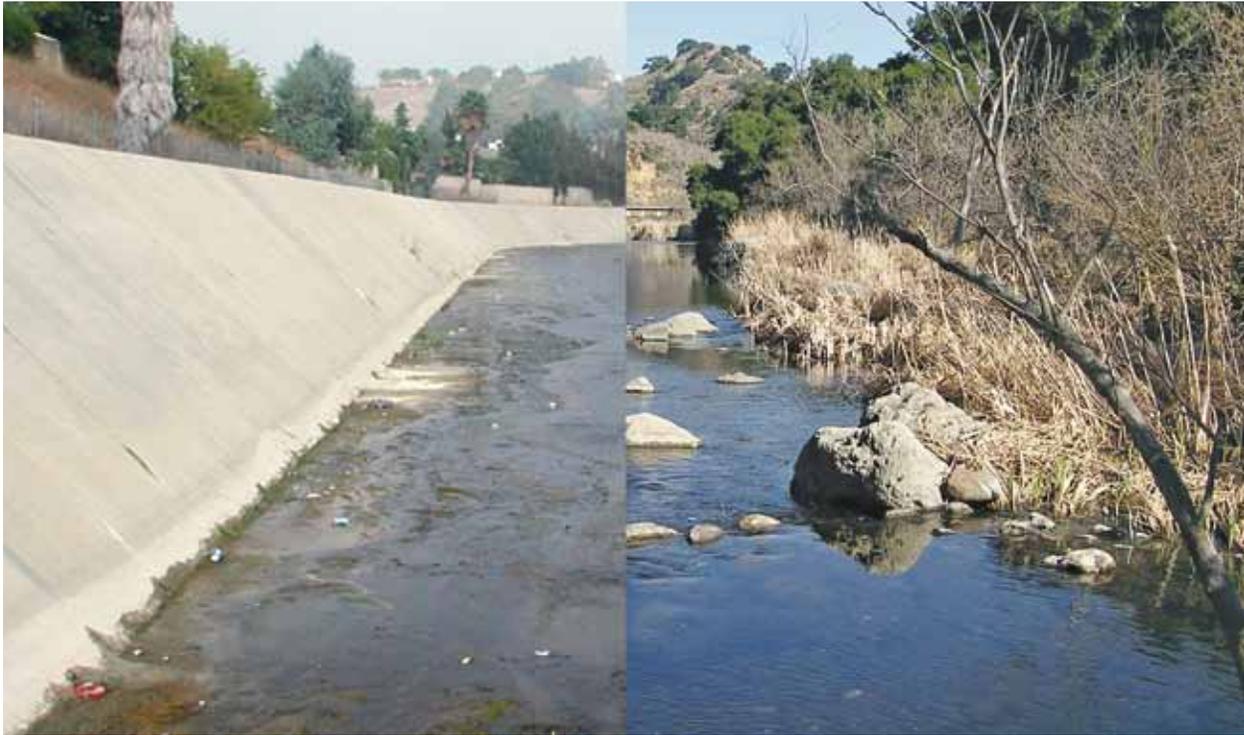
*Streams of the watershed in hardened and natural states. Photo credit: Heal the Bay*

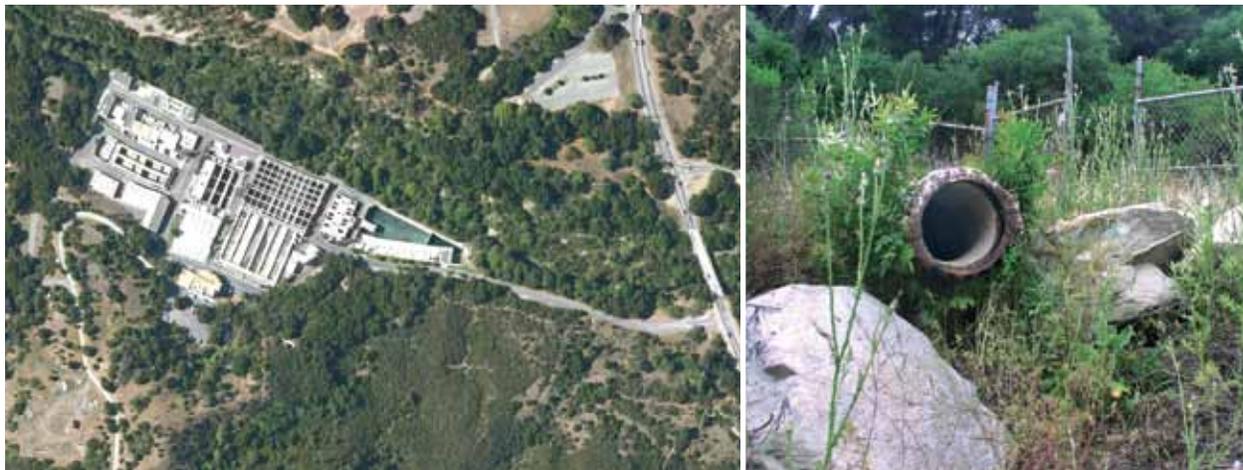
Aerial view (top) and outfall pipe (right) of Tapia Water Reclamation Facility. Photo credit: Google Maps

LVMWD conducts water quality monitoring along Malibu Creek, including two sites above the Tapia outfall, one site just below the outfall, and a fourth site slightly further down the creek. However, none of the sites are above the influence of Tapia's composting, irrigation, and previous sludge injection operations. Based on average monthly wet season data reported in the LVMWD annual reports for Tapia (2006 through 2009), average nitrogen increases dramatically downstream of the outfall (Figure 3-6). Above the outfall, Tapia monitoring site 1 has a higher average nitrogen concentration than Tapia site 9, which is further upstream. This may be related to water recycling activities that drain into Las Virgenes Creek in this area. The total nitrogen TMDL estimates that Tapia contributes 30% of the nitrogen loading to the Malibu Creek Watershed annually, despite only five months of discharge.<sup>38</sup>

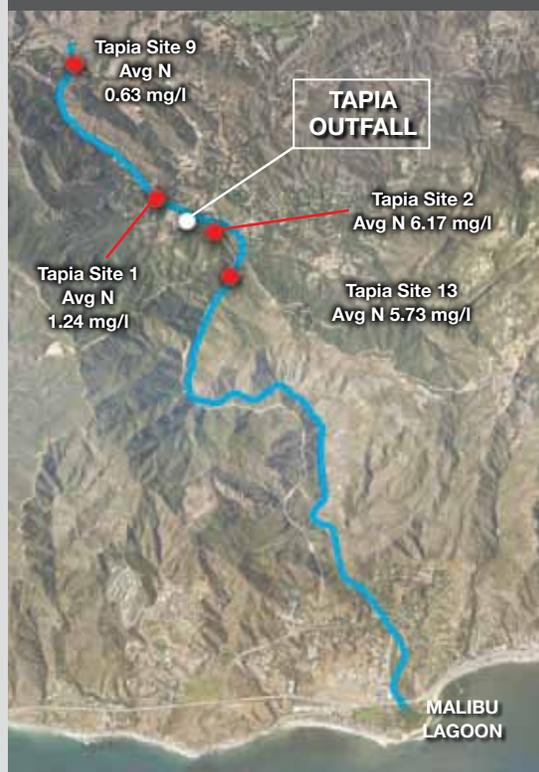
Figure 3-6: Avg. Total Nitrogen Concentrations at Las Virgenes Municipal Water District's Monitoring Locations (above and below Tapia)

FIGURE 3-6: Water chemistry monitoring locations in the Malibu Creek Watershed above and below the Las Virgenes Municipal Water District Tapia Water Reclamation Facility discharge, with average total nitrogen concentrations above and below the Tapia outfall between 2006 and 2009 during wet season discharge months (November 16th – April 14th). Values were obtained from Tapia 2006-2009 NPDES annual reports and were reported monthly; we used data from December to March to calculate wet season averages. Since that time, Tapia has greatly reduced their total nitrogen discharge due to the facility's nitrification/denitrification retrofit.

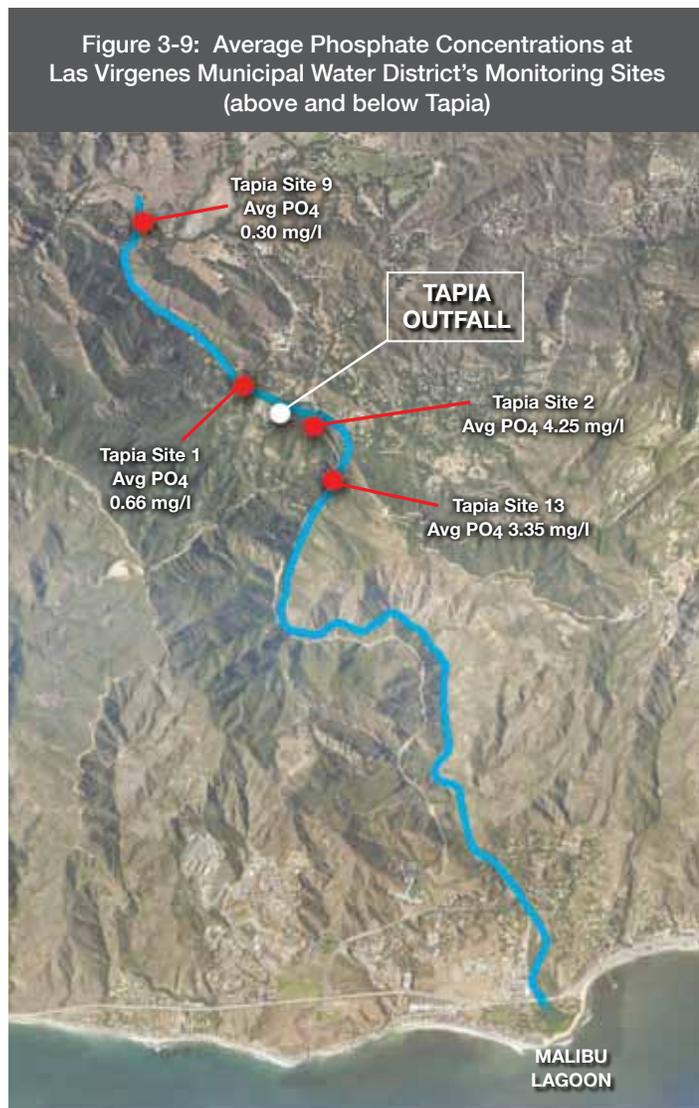
FIGURE 3-9: Average phosphate (mg/L) concentrations above and below the Tapia outfall between 2006 and 2009 during the permitted discharge period (November 16-April 14). Values were obtained from Tapia 2006-2009 NPDES annual reports and were reported monthly; we used data from December to March to calculate wet season averages. LVMWD monitoring locations are those shown in the Tapia 2009 NPDES Permit. The reported total phosphorus was converted to phosphate by multiplying by 3.<sup>45</sup>

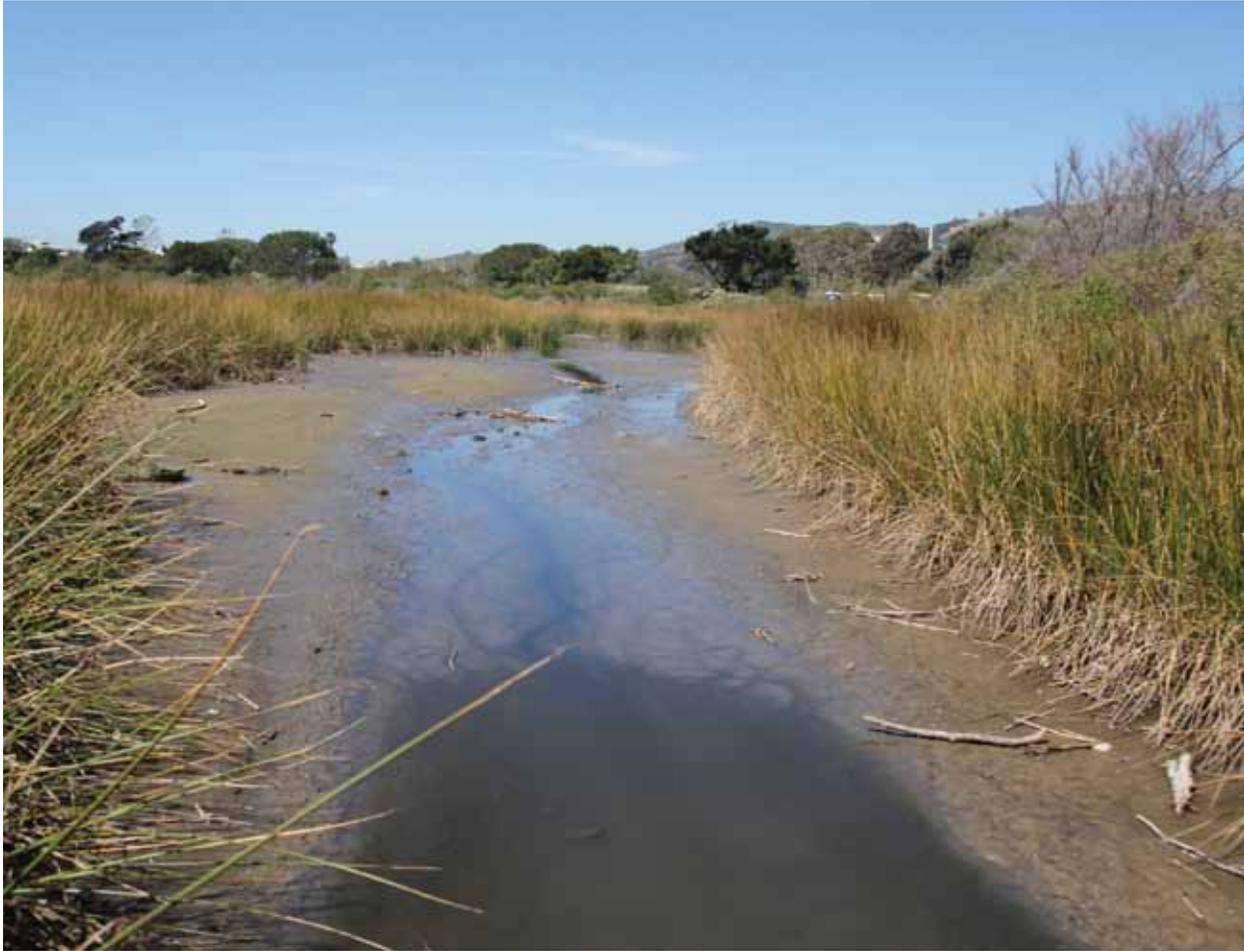
Malibu Lagoon suffers low Dissolved Oxygen (DO). Photo credit: Joy Aoki

The Malibu Lagoon suffers low Dissolved Oxygen (DO) levels, a condition that threatens aquatic life. In a 2005 study, pre-dawn dissolved oxygen concentrations averaged  $1.15 \pm 0.12$  mg/L SE, significantly below Basin Plan thresholds.<sup>57</sup> Concentrations below 5 mg/L threaten aquatic life survival, and periods of low dissolved oxygen and low species diversity have been recorded in the lagoon since the early 1990s.<sup>58</sup> For this reason, along with extensive sedimentation and eutrophication, a comprehensive planning effort was initiated in the late 1990s and early 2000s to restore the Malibu Lagoon, with the primary objectives of improving water quality through increased circulation and enhancing lagoon habitat for birds, fish, and invertebrates. The goals and design of the restoration plan grew out of a long-term multi-stakeholder process that included a diverse group of local residents, agencies, wetland restoration scientists, and environmental groups, including California State Parks and Recreation, the California State Coastal Conservancy, Santa Monica Bay Restoration Commission, and Heal the Bay.

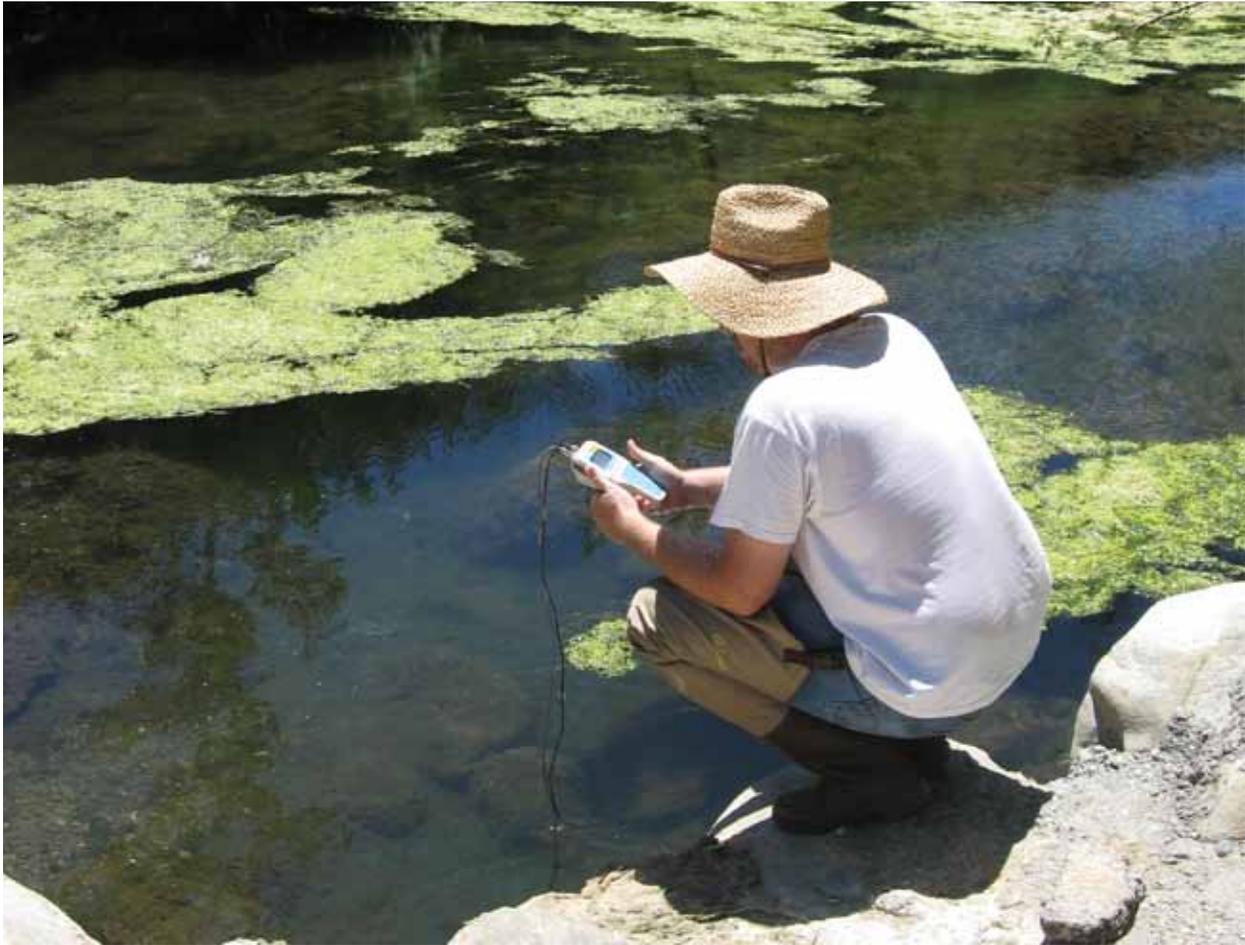
Stream Team staff measuring conductivity. Photo credit: Heal the Bay

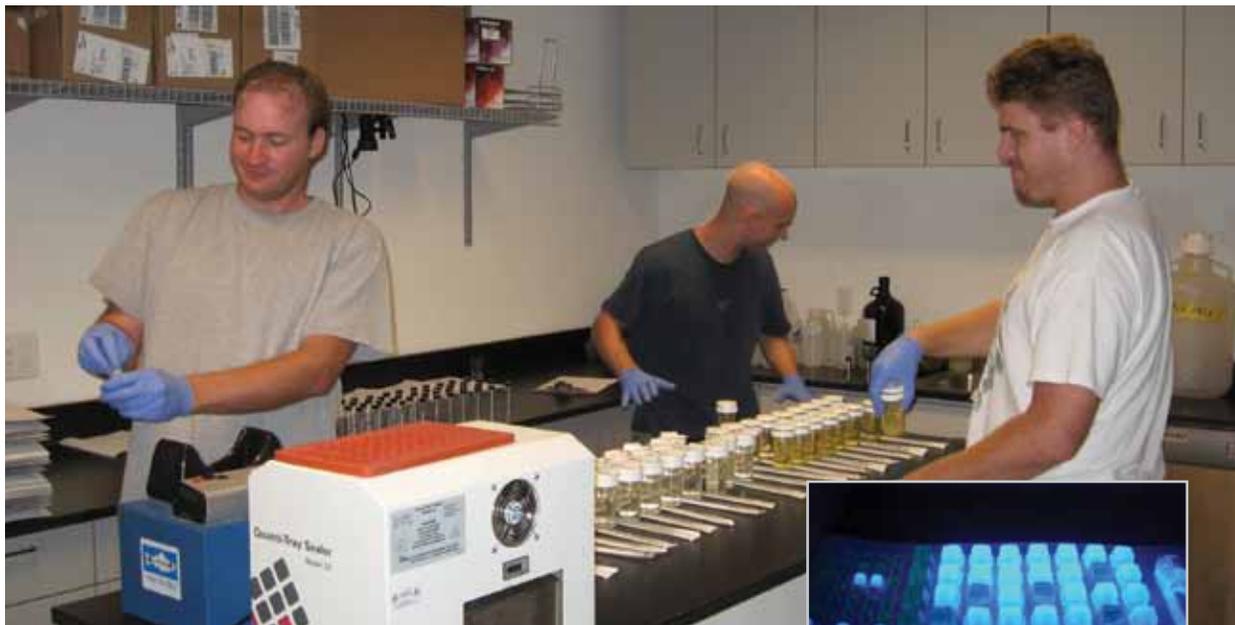
Stream Team staff and volunteers conduct laboratory testing for fecal indicator bacteria (top); a positive test for presence of fecal indicator bacteria (right).

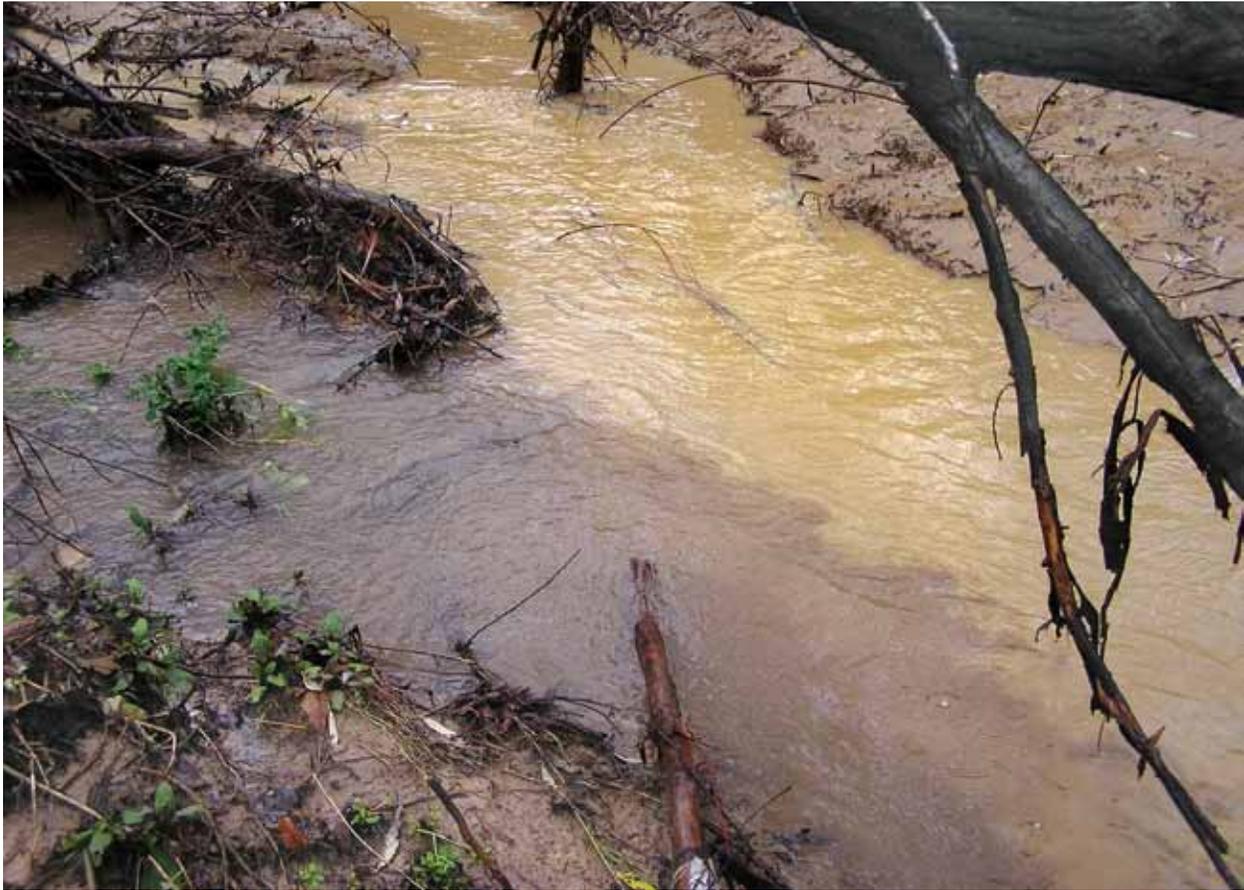
High turbidity caused by upstream construction. Photo credit: Heal the Bay

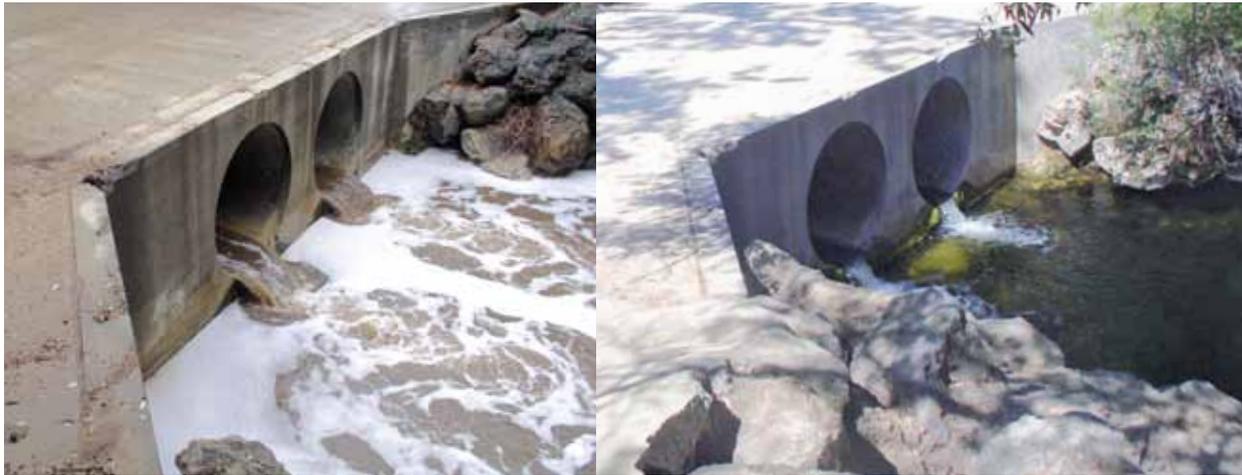
Culvert at Las Virgenes Creek showing high (left) and low (right) turbidity. Photo credit: Heal the Bay

NTU is an extremely high standard. Only two percent of turbidity samples taken by Heal the Bay throughout the watershed, typically in dry weather, exceed 10 NTU. Based on research from Dr. Richard Horner, a nationally renowned stormwater engineering expert, implementing BMPs including mulch and blanket materials achieves effluent with a maximum turbidity of 73 NTU. This research was submitted to the State Water Resources Control Board by Dr. Horner in May 2007.<sup>71</sup> However, despite this information and a large number of studies supporting lower effluent limits, the most recent general construction stormwater permit approved by the State Water Resources Control Board does not even have a turbidity limit. The permit needs to set a numeric effluent limit for turbidity that is strong and protective of water quality and riparian habitat.

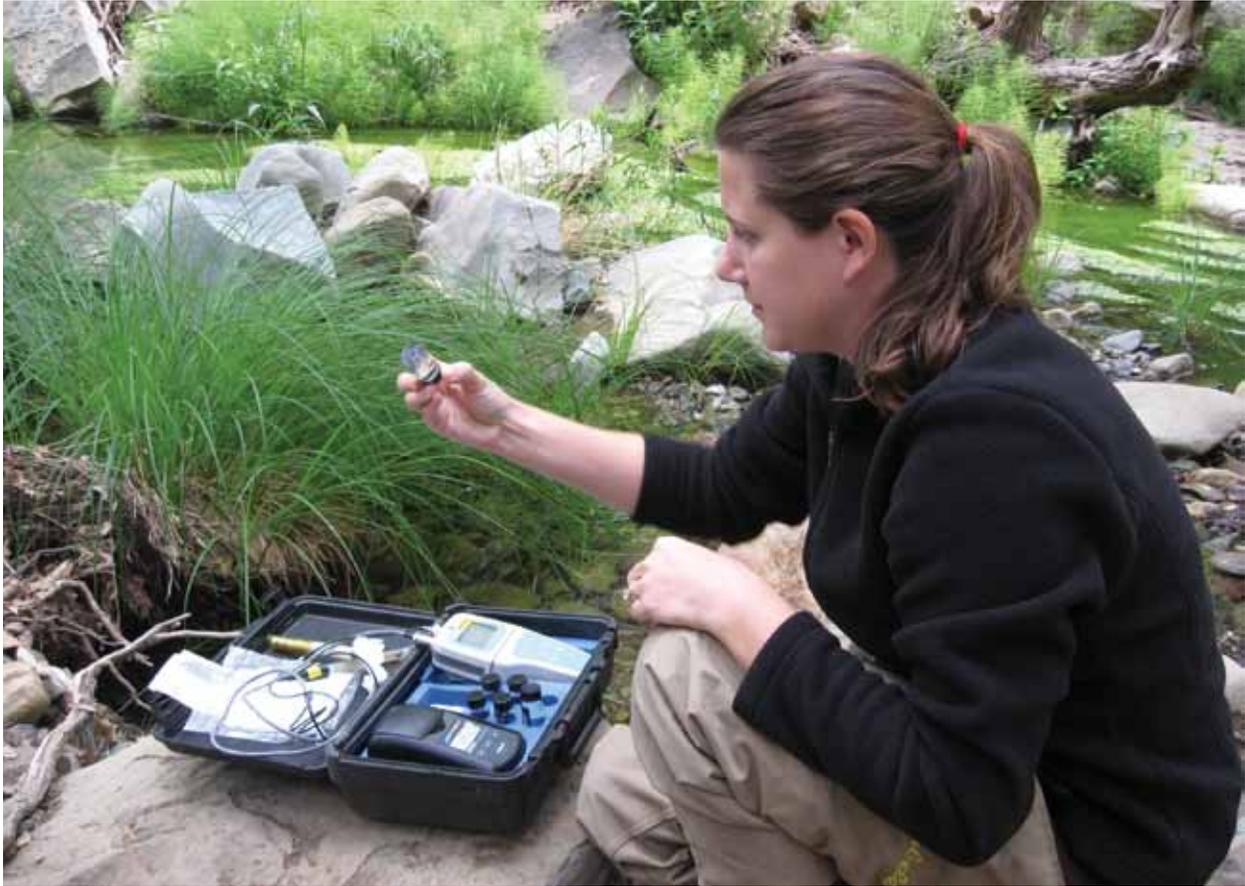
Stream Team Volunteer sampling turbidity. Photo credit: Heal the Bay
