MALIBU CREEK WATERSHED  
Ecosystem ON THE **Brink**

A SCIENTIFIC ROADMAP FOR PROTECTING A CRITICAL NATURAL RESOURCE

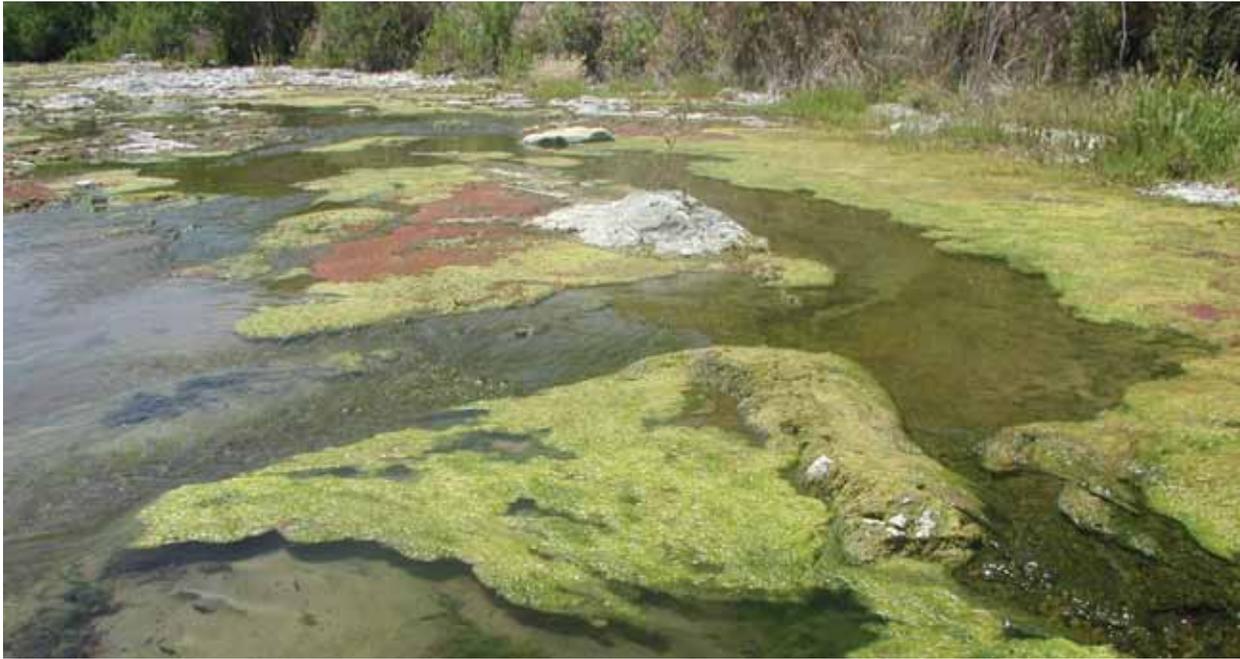
Algae growth in Triunfo Creek. Photo credit: Heal the Bay

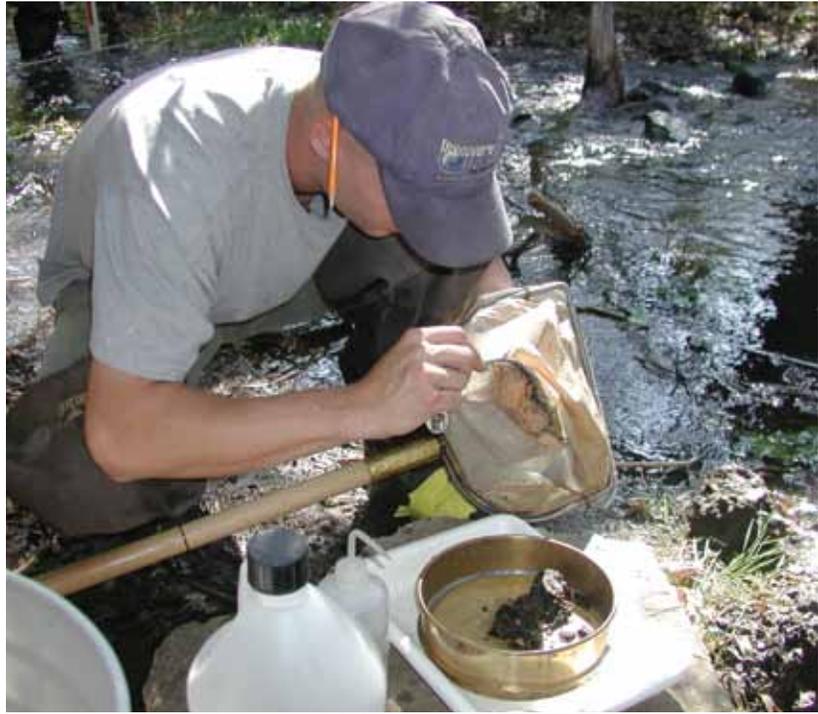
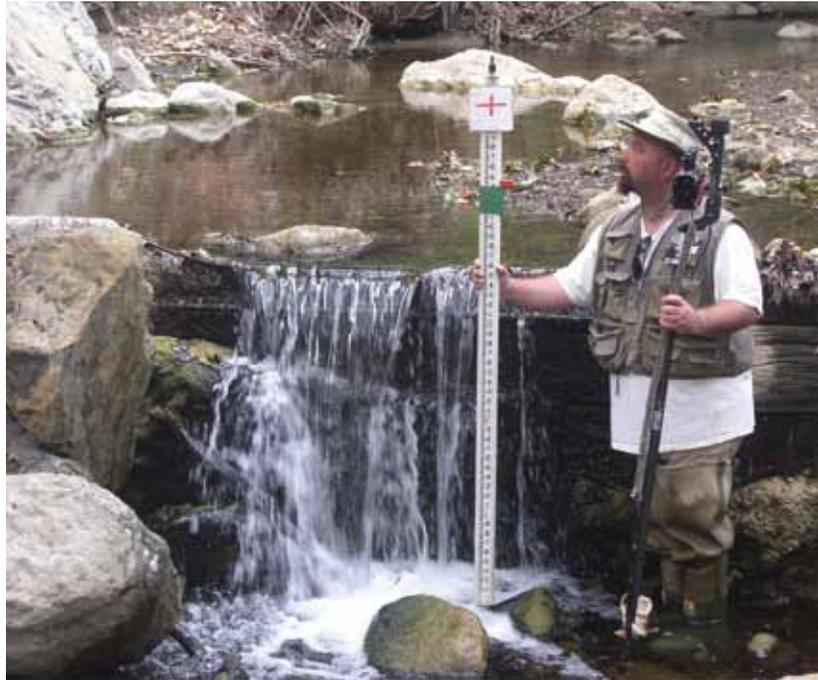
Bioassessment sampling by Heal the Bay staff. Photo credit: Heal the Bay

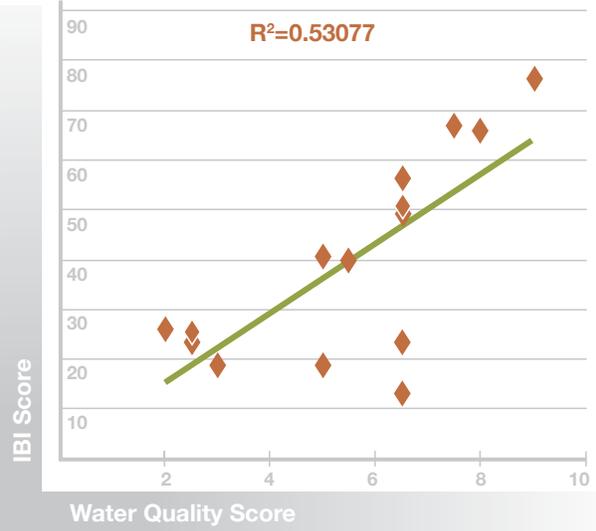
**Figure 5-1: Water Quality Score Influence on Mean IBI Score**

FIGURE 5-1: There is a moderate correlation between mean IBI score and WQS, revealing a trend where improved water quality leads to higher IBI scores ( $R^2 = 0.5308$ ).

The WQS for our monitoring sites ranged from 2 to 9 points (see Table 5-4). The lowest WQS of 2 points occurred at the outlet of Las Virgenes Creek (O5). Cold Creek (R3) scored the highest with 9 points. The WQS was compared to the IBI scores for sites monitored for BMI (Figure 5-1). The average IBI scores improved with higher WQS, indicating a trend between good water quality and biotic health ( $R^2 > 0.5$ ).

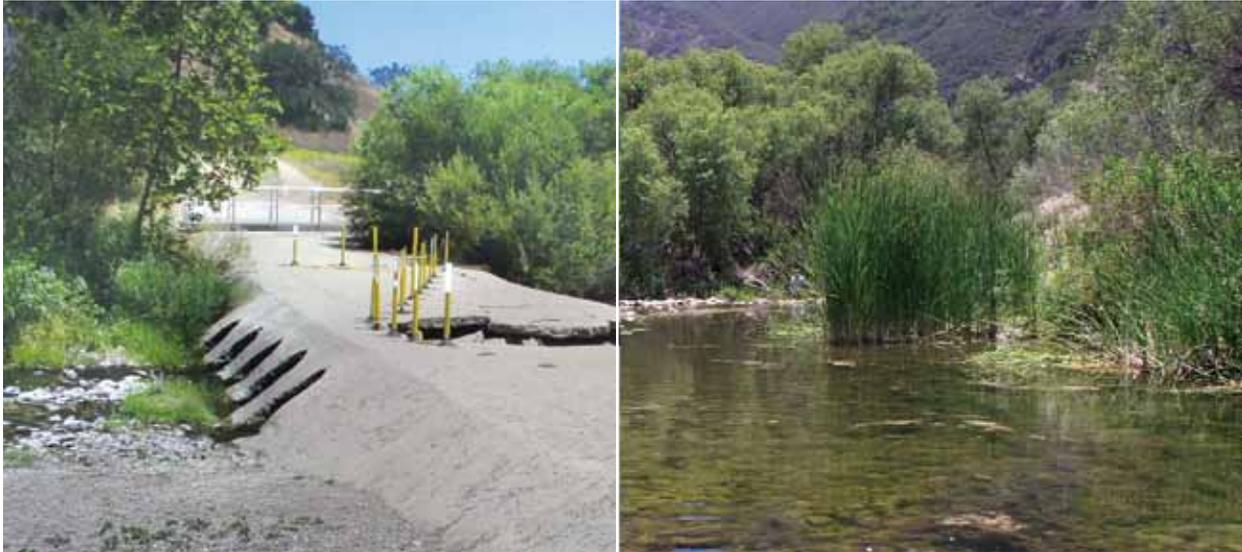
*Before and after removal of a barrier in Malibu Creek.*

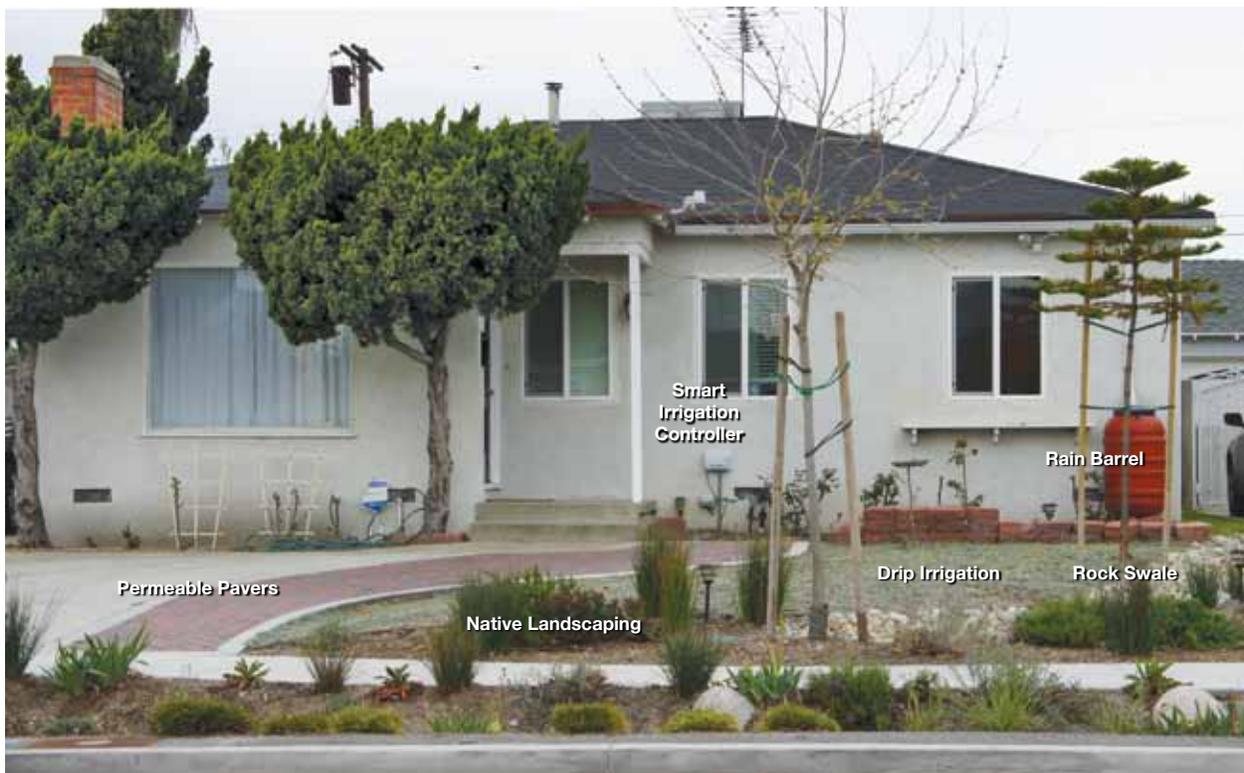
Local governments should adopt Low Impact Development (LID) ordinances that require onsite capture and reuse, or infiltration of 100% of the runoff generated from the 85th percentile storm. Pictured: Elmer Ave. Sun Valley LID demonstration house.

Local governments throughout the watershed should adopt Low Impact Development (LID) ordinances or policies for all new development and re-development that require onsite capture and reuse, or infiltration of 100% of the runoff generated from the 85th percentile storm. In fact, this is required under the recently-adopted MS4 permit. Additionally, since percent impervious area has a strong influence on degraded water quality, a comprehensive LID retrofit program needs to be developed watershed-wide that targets the biggest potential sources of impairing pollutants (nutrients and bacteria). For retrofits and future ordinances, we suggest reducing percent impervious area to 6.3% or less through LID implementation.

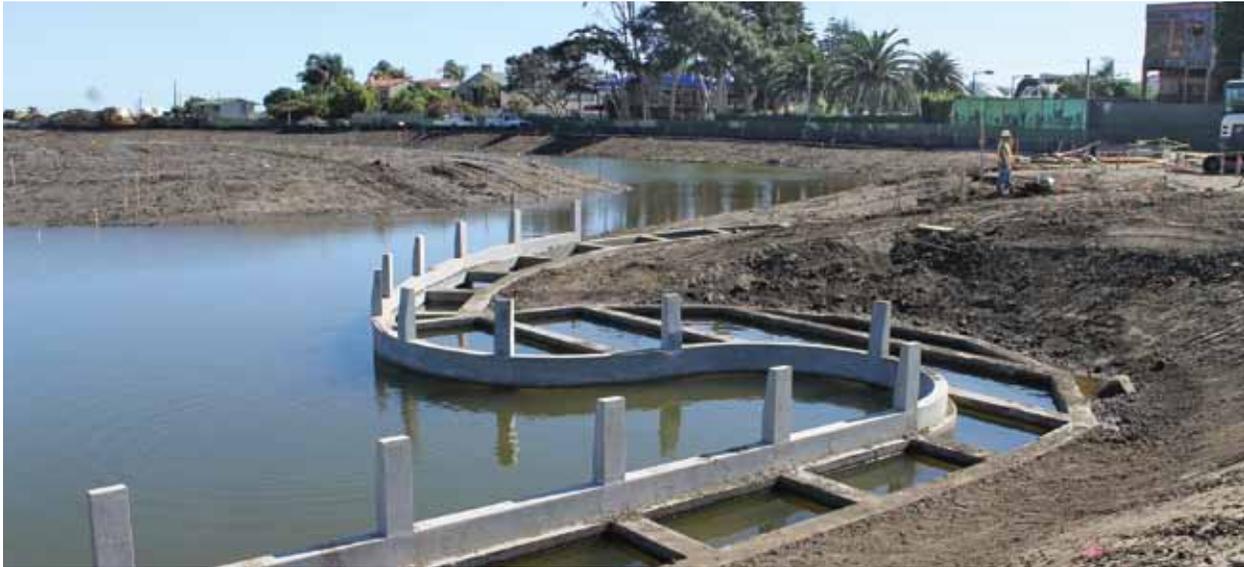
*The Malibu Lagoon Restoration and Enhancement Project currently underway will greatly help improve circulation and aquatic habitat conditions. Photo: Heal the Bay*

The Malibu Lagoon Restoration and Enhancement Project currently underway for Malibu Lagoon will greatly help improve circulation and aquatic habitat condition in this critical wetland. Completion and proper management of this project is critical to restoring the overall biological condition of the lower watershed.
